DYNAMIC SCIENCE, INC.
In-Depth Accident Investigation

Case Number: DS96005

1. Report No. DS96005	2. Government Accession No.	3. Recipient Catalog No.	
4. Title and Subtitle In-Depth Accident Investigation		5. Report Date 1996	
		6. Performing Organization Report No.

14. Sponsoring Agency Code	
15. Supplemental Notes			
<p>16. Abstract</p> <p>An unrestrained and out of position 3 year old female, located at the right front seating position, sustained fatal head and neck injuries from contact with the deploying front right passenger's air bag and air bag module flap.</p> <p>Vehicle 1, a 1995 Chevrolet Geo Metro LSi three-door, was being driven north, in the northbound travel lane at a speed estimated to have been between 48 and 56 km/h (30 and 35 mph) by the 15 year old female driver who was not restrained by the available three-point, manual lap/shoulder restraint. Occupant 2, a 15 year old female, was seated in the right front seating position unrestrained by the available three-point, manual lap/shoulder restraint. Occupant 3, a 3 year old female (the case occupant) was seated, unrestrained on the lap of Occupant 2 in the front right seating position. As Vehicle 1 was negotiati

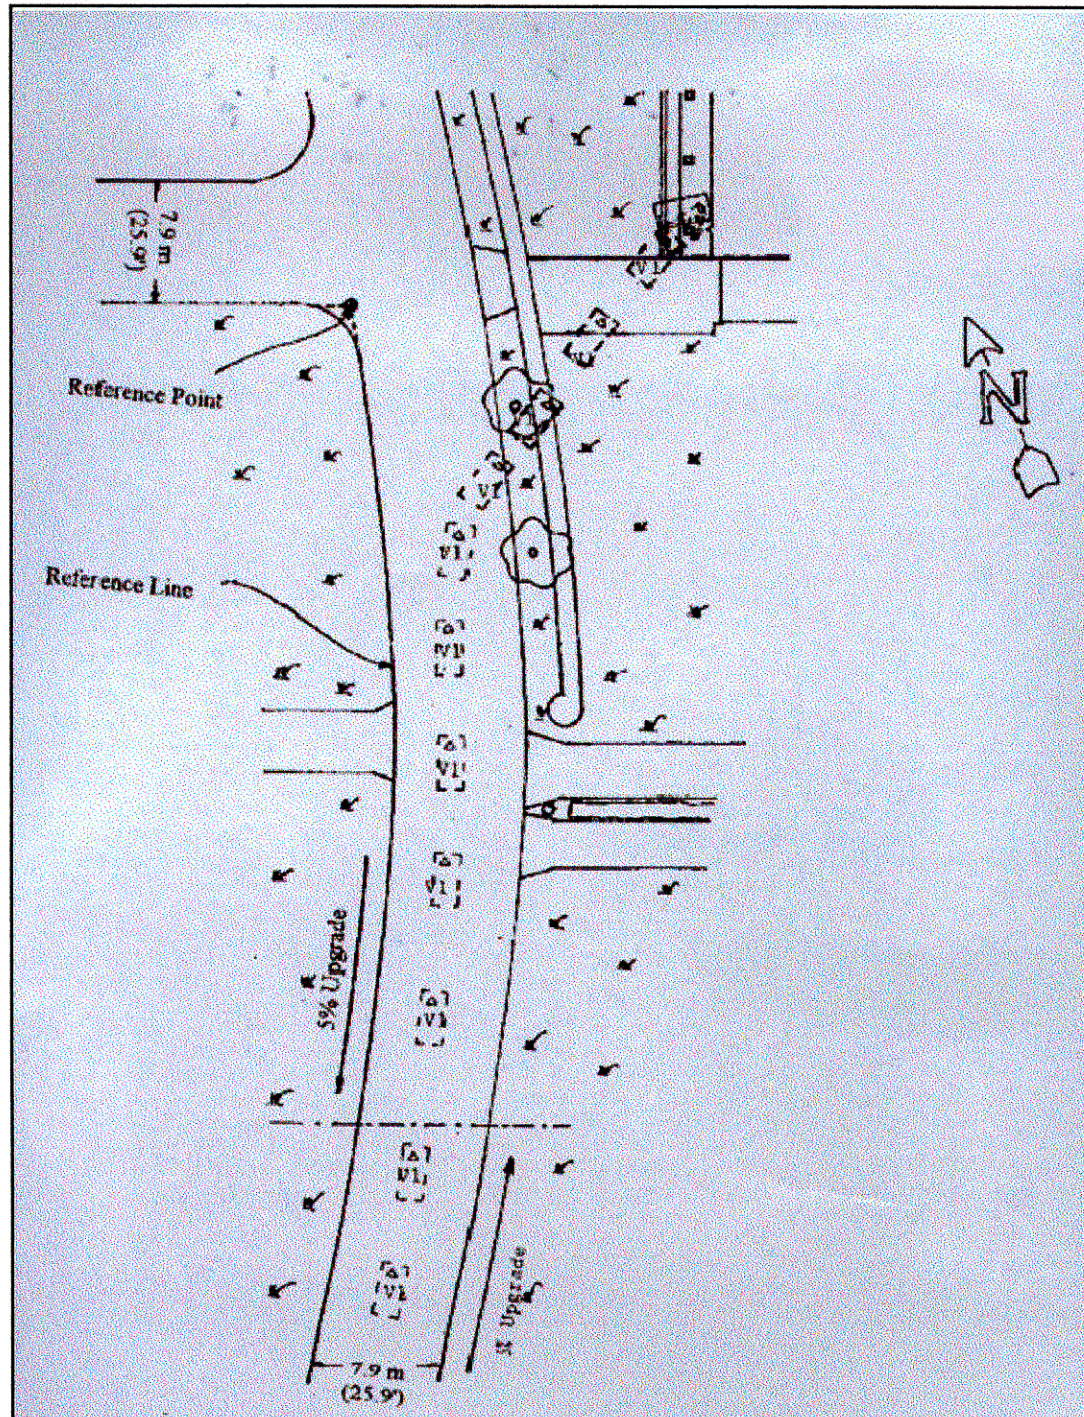
SCENE DIAGRAM

DATA POINT	DISTANCE AND DIRECTION FROM REFERENCE POINT	DISTANCE AND DIRECTION FROM REFERENCE LINE
W curb N/S roadway	24.4 m (80.0 ft) S	0
E curb N/S roadway	24.4 m (80.0 ft) S	7.9 m (25.9 ft) E
Vehicle 1 departs roadway	10.1 m (33.2 ft) S	7.9 m (25.9 ft) E
POI # 1, wood column	4.5 m (14.8 ft) N	20.8 m (68.1 ft) E
POI # 2 and FRP	5.3 m (17.4 ft) N	22.8 m (74.7 ft) E

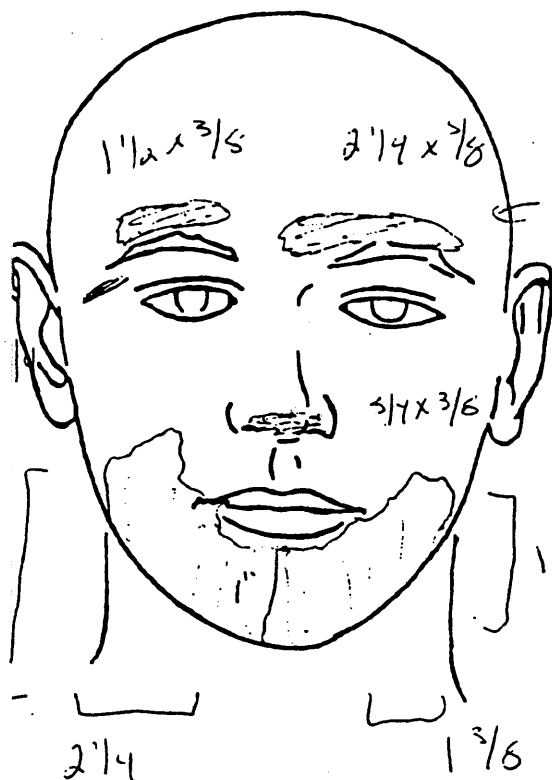
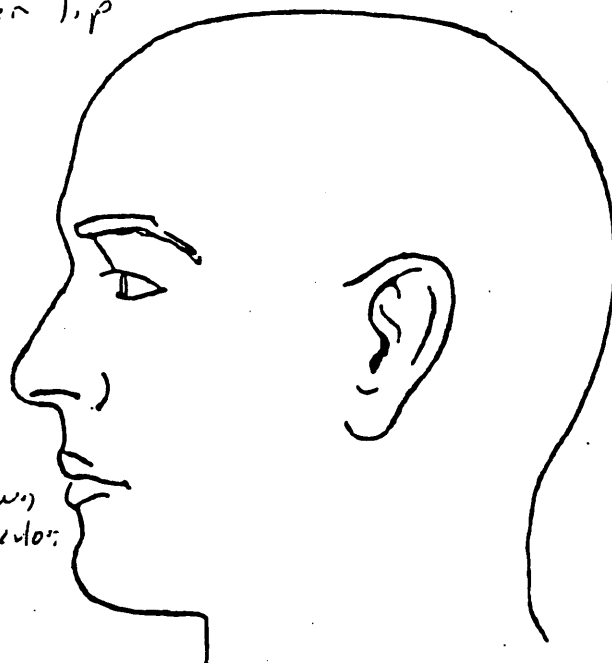
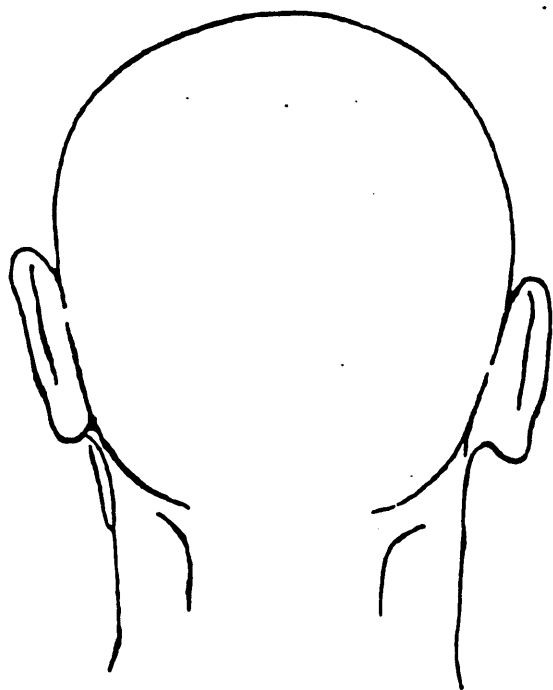
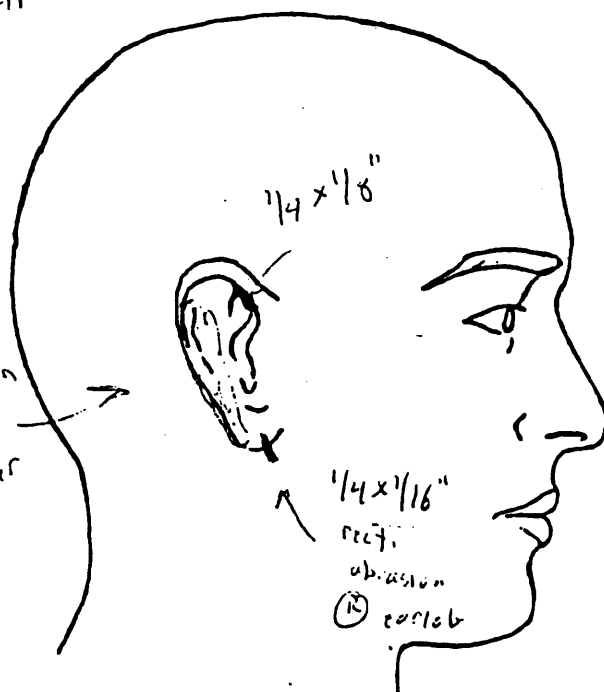
marked drying of
lips - both (VI) & (L)
frenulum torn c
1/4 x 1/8 lac. of
midline lower lip

Both lips sup.
abraded.

$2 \times \frac{3}{8}$
deep abrasion
on post.
lat. (R) ear

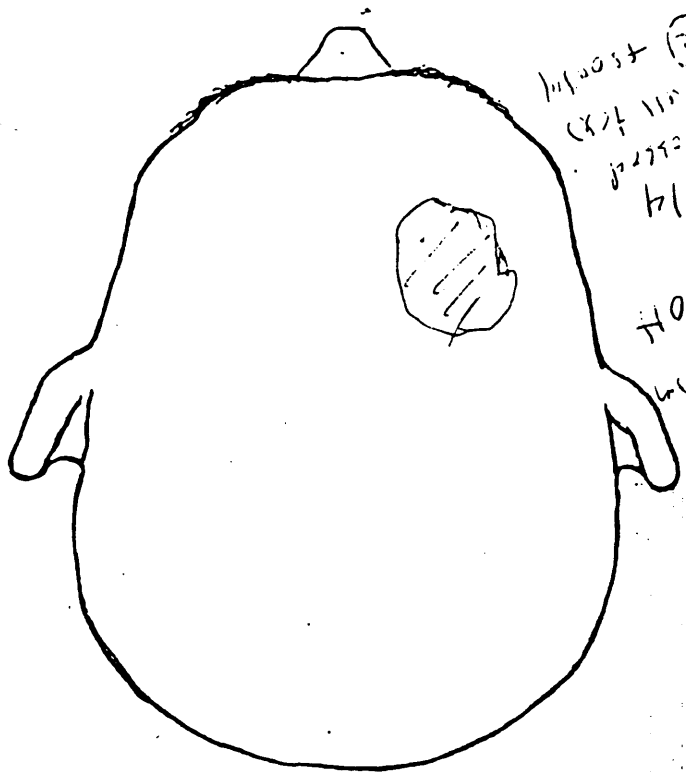
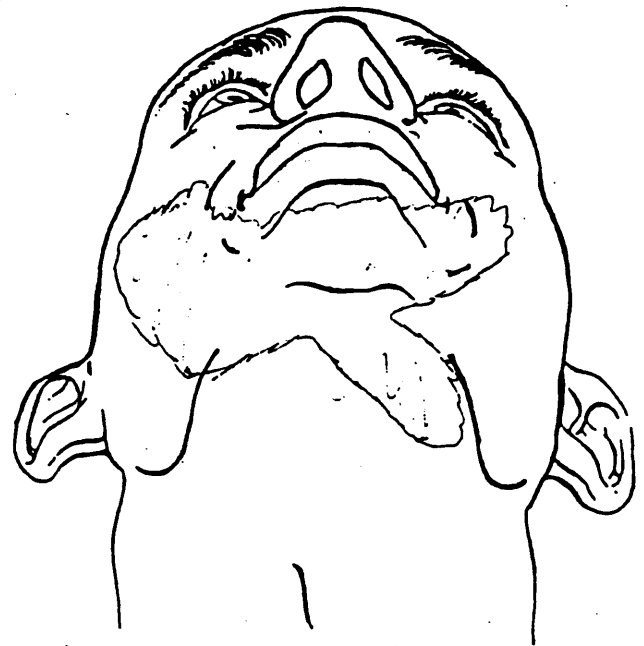
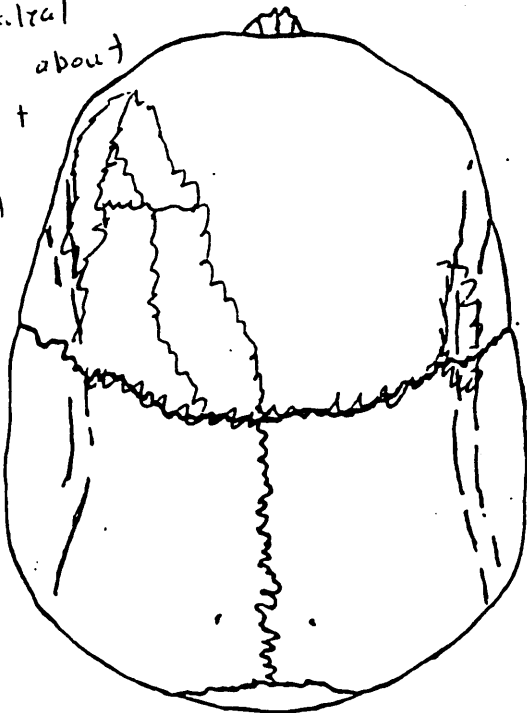
②
depressed
skull fx
1 1/4" x 1 1/4"
1" B704
② 1/2" x 1/2"

Extensive
subgaleal
hem. about
Frontal +
ant.
Parietal
scalp
-Some
over
post.
parietal

abrasion extends
from 1/2" (midline) to
1" ② side undersurface
of jaw.
